# Trip to Sunshine Coast Queensland, September 2004 Visit to Schools

## Report No 2002-059-B No 7

**Project Name** Case Based Reasoning in Construction and Infrastructure Projects

**Date:** January 2005

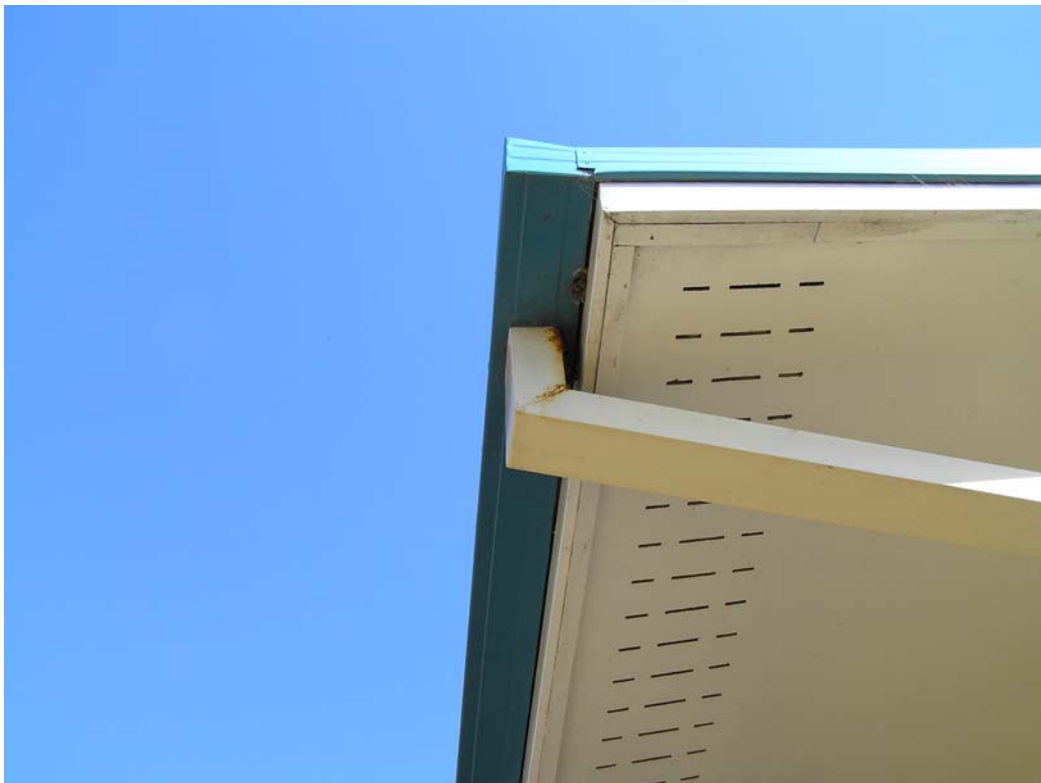
Figure 6 Rusting and deterioration on gutter on Modular 1

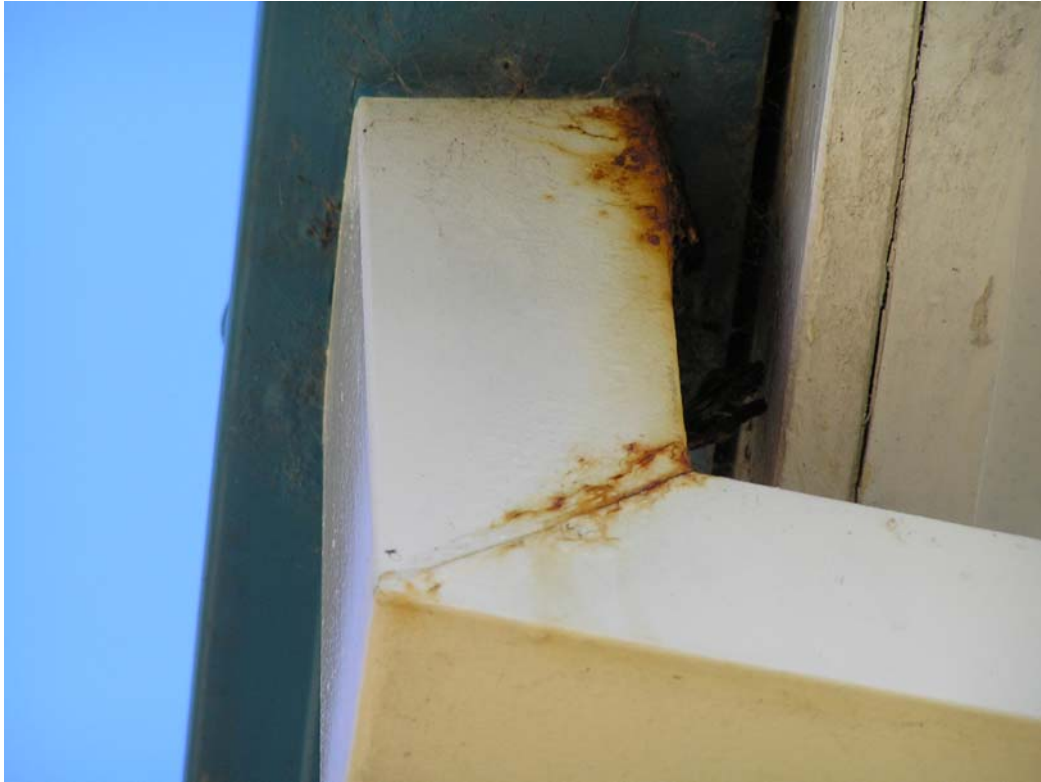
Figure 7 Close up of rusting and deterioration on gutter on Modular 1 showing that problems are associated with the joints.

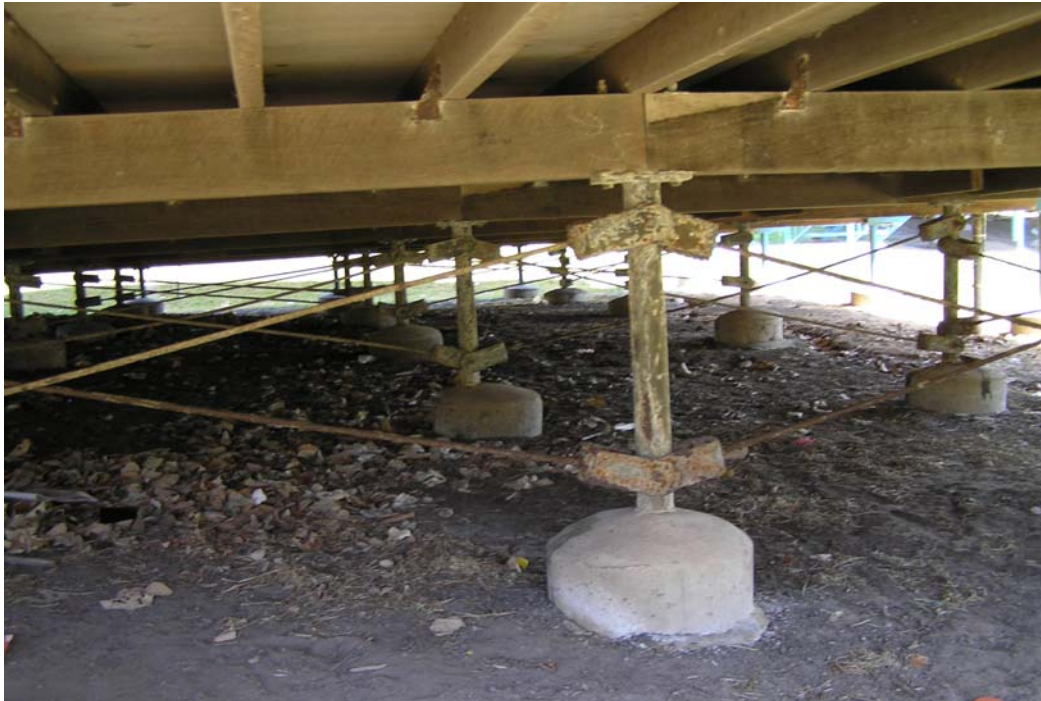
Figure 8 Sub-floor of Modular 1 showing significant deterioration of sub floor metallic components.

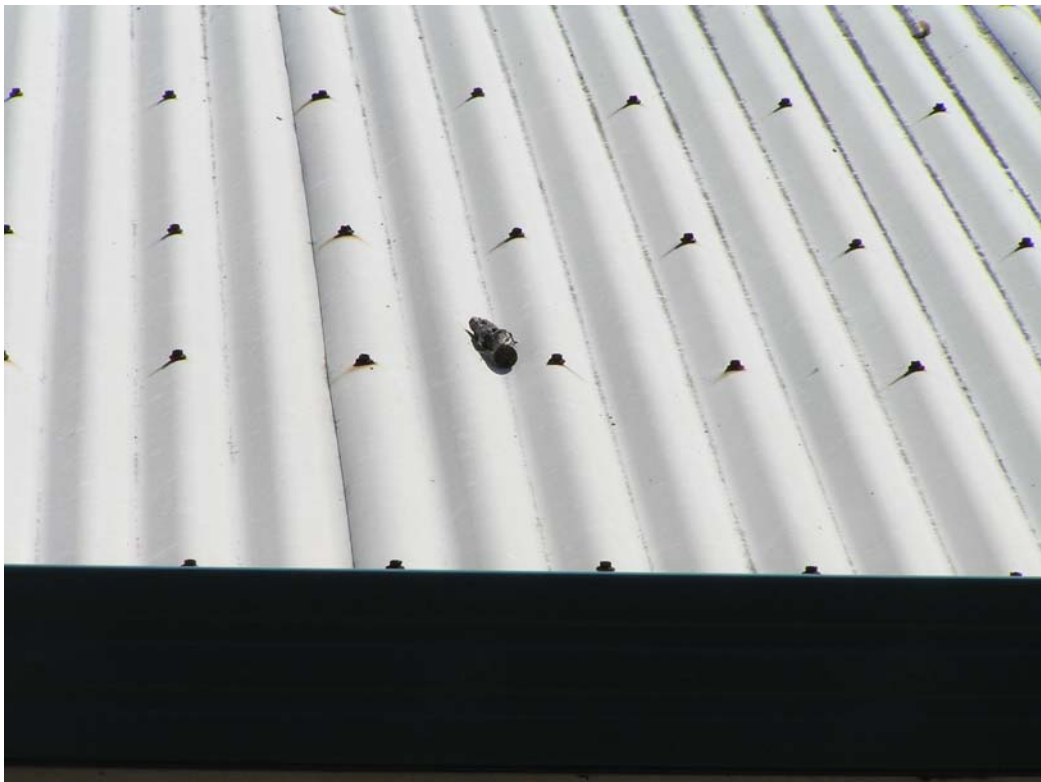
Figure 12 Fasteners on roof of Modular 1 showing rust staining on to sheeting.

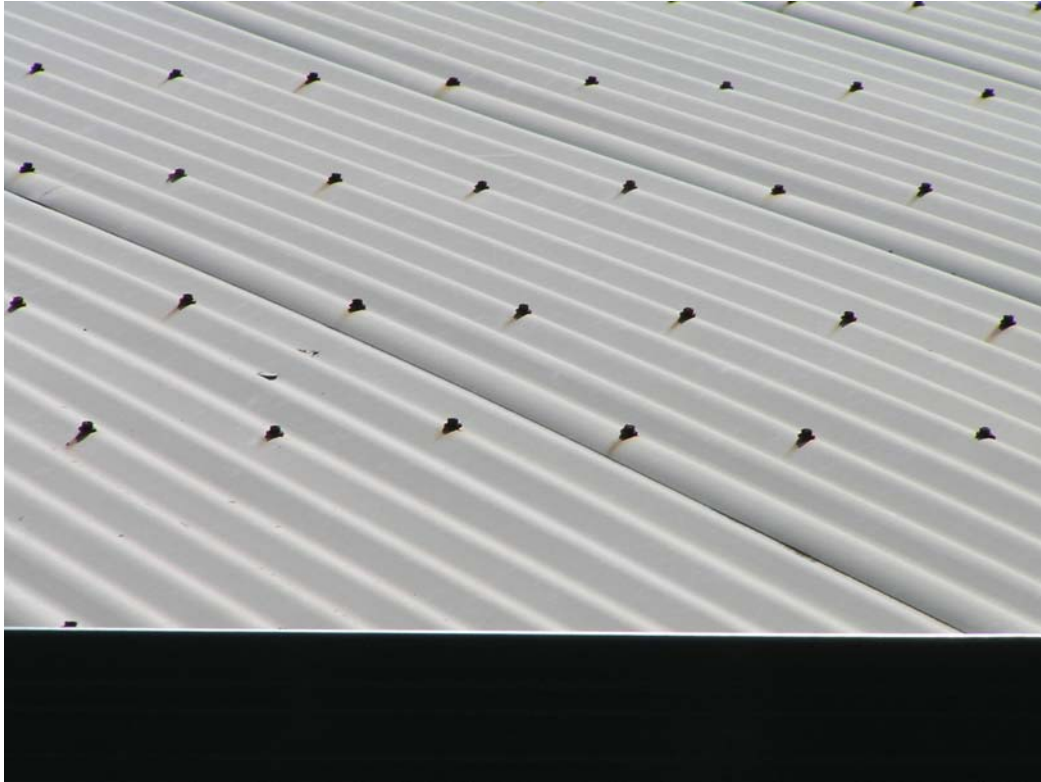
Figure 13 Fasteners on roof of Modular 1 showing rust staining on to sheeting.

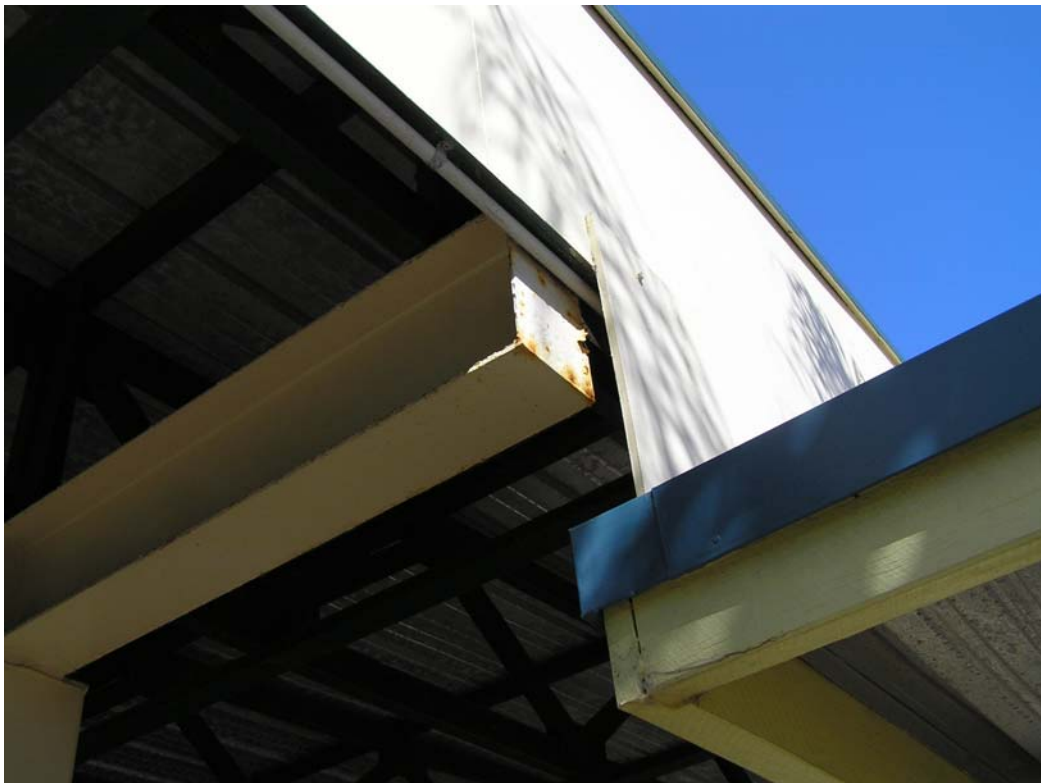
Figure 16 End of steel beam showing red rust break through.

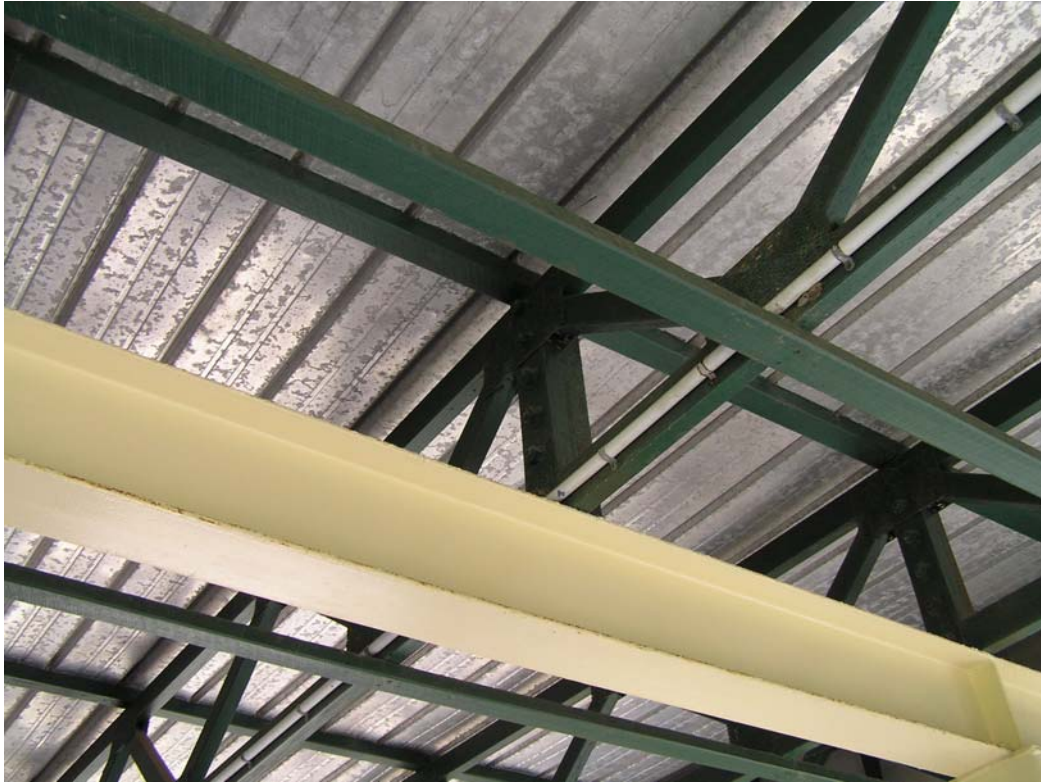
Figure 17 Inside covered games area showing corrosion of underside of roof sheeting and rust on edges of beams.

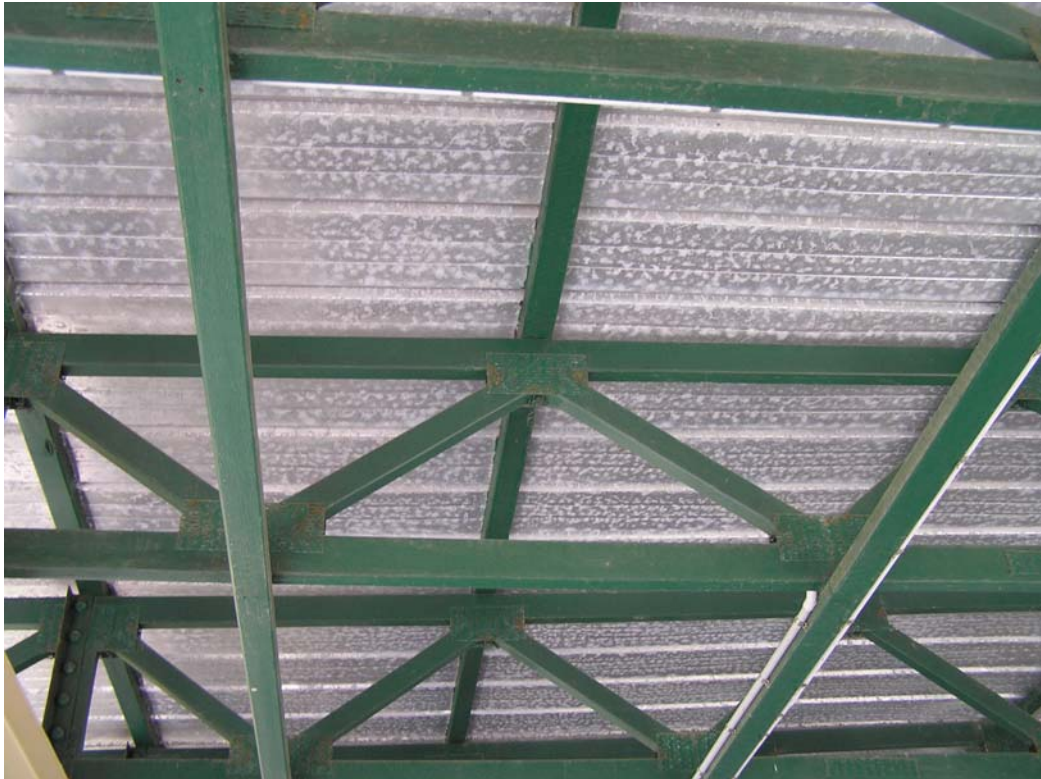
Figure 18 Inside covered games area showing corrosion of underside of roof sheeting and rust on painted gang nail plates.

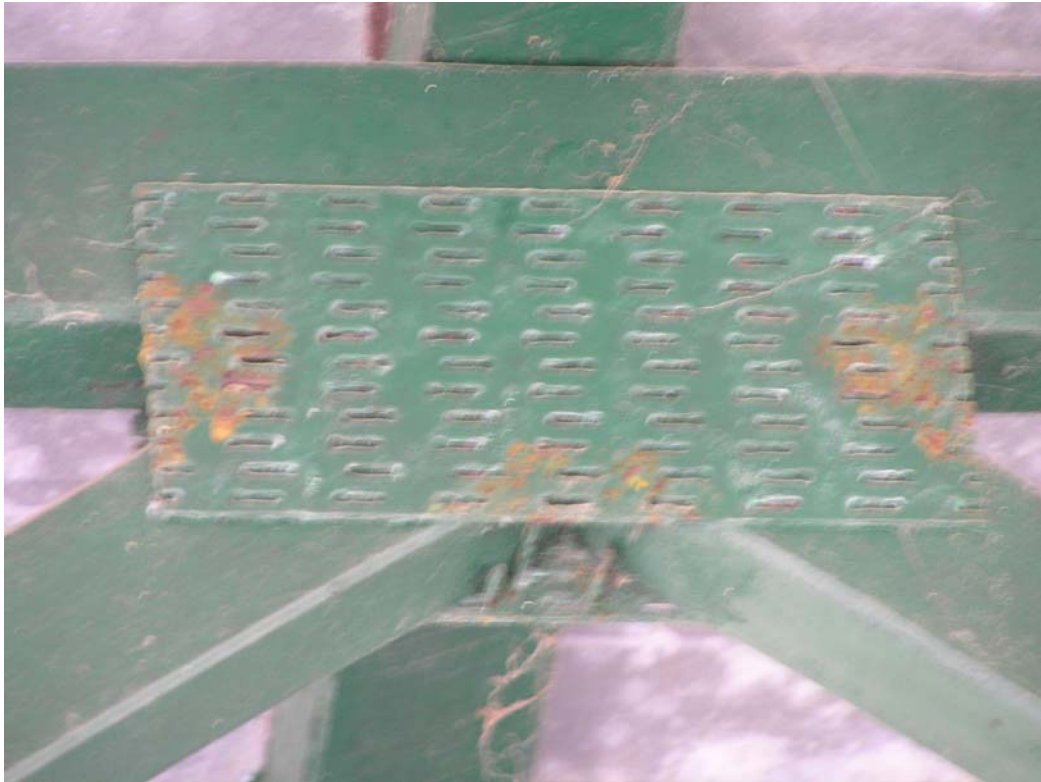
Figure 19 Close up of gang nail plates on inside of covered games area.

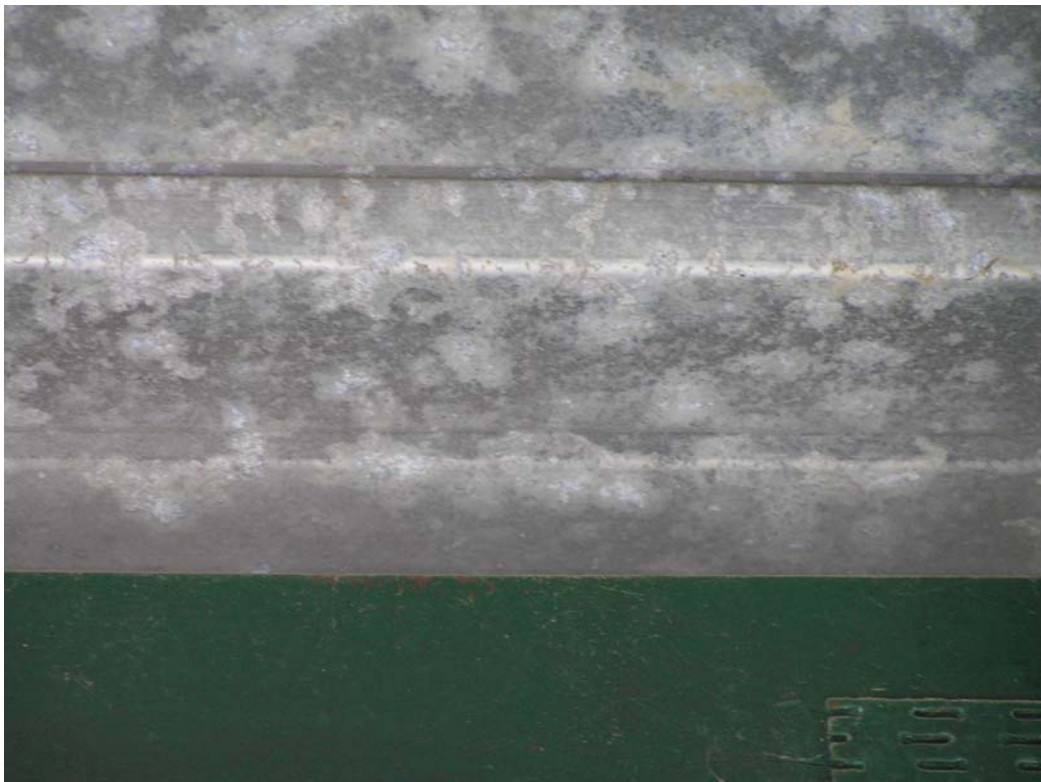
Figure 20 Close up of inside of roof sheeting of covered games area showing significant white corrosion product and some red rust.

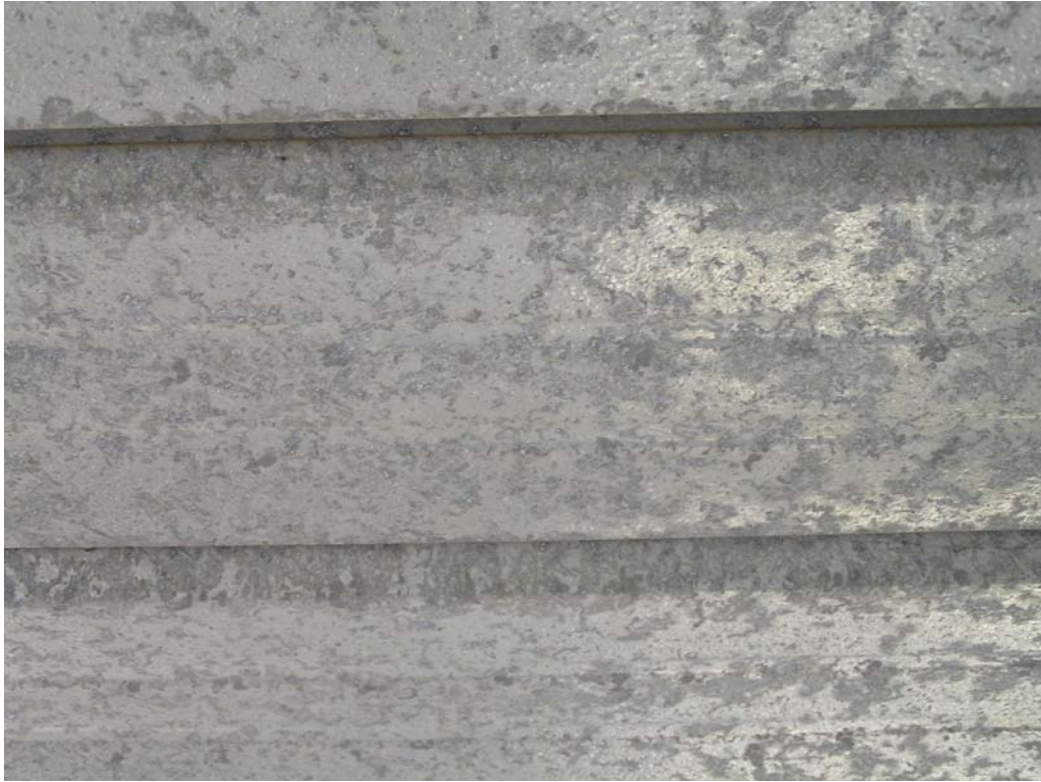
Figure 21 Close up of inside of roof sheeting of covered games area showing significant white corrosion product.

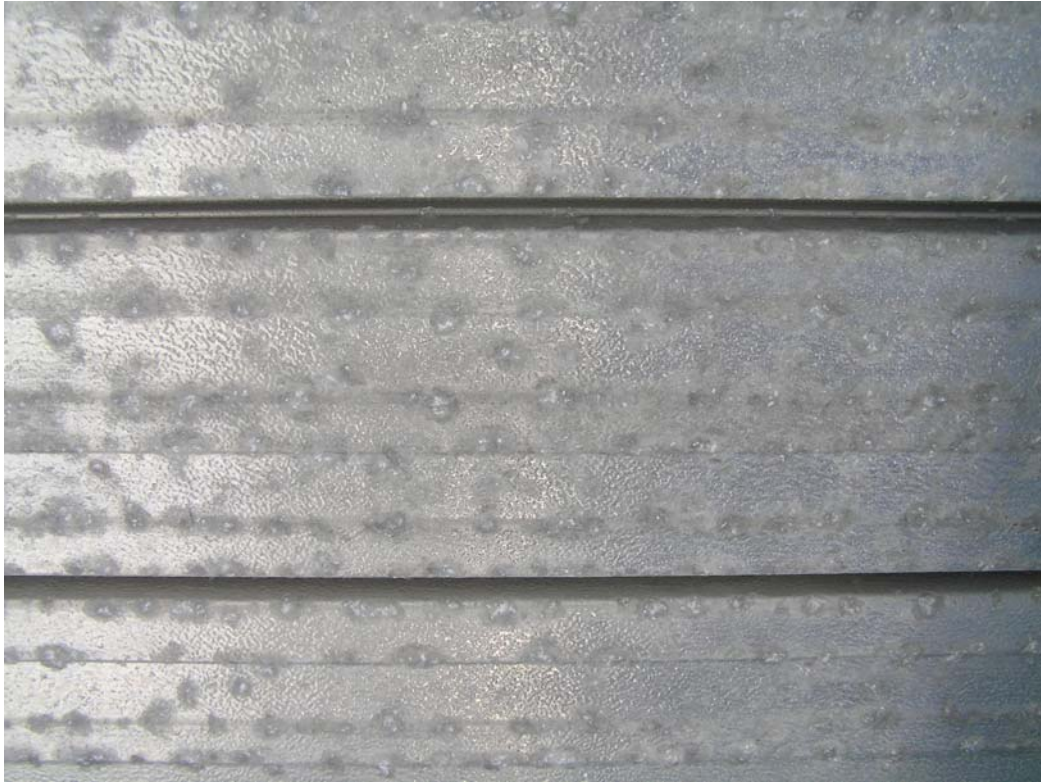
Figure 24 Close up of covered walkway showing significant white corrosion product, possibly aluminium construction.

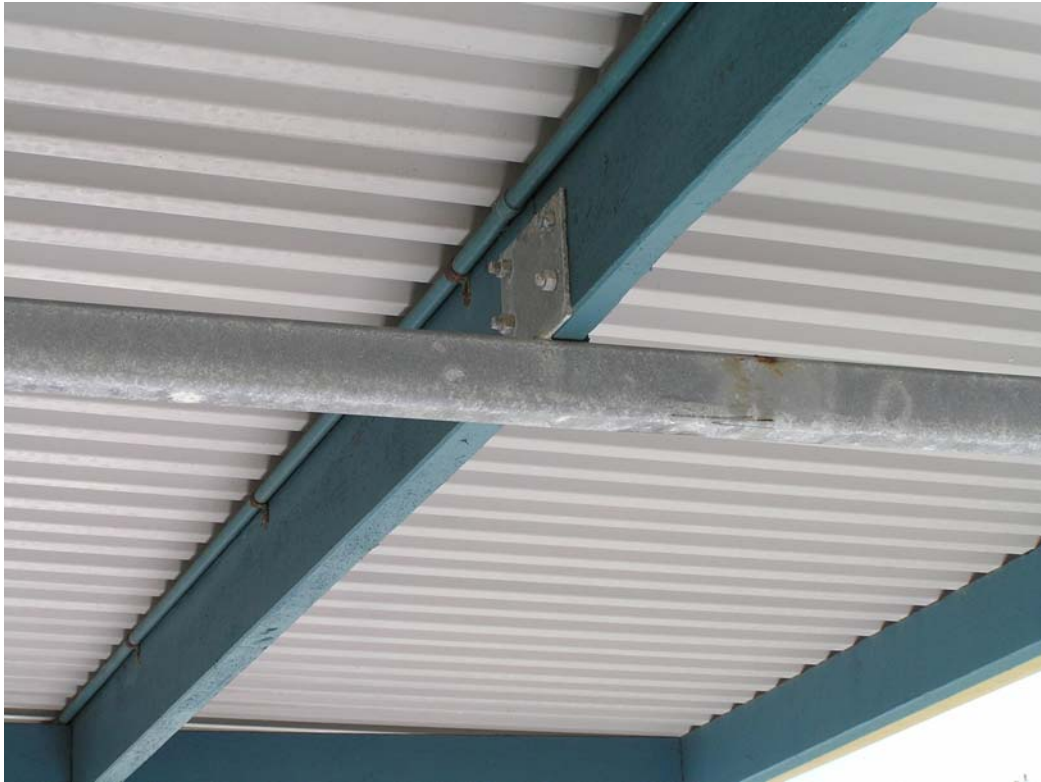
Figure 25 Covered walkway showing corrosion of galvanised support.

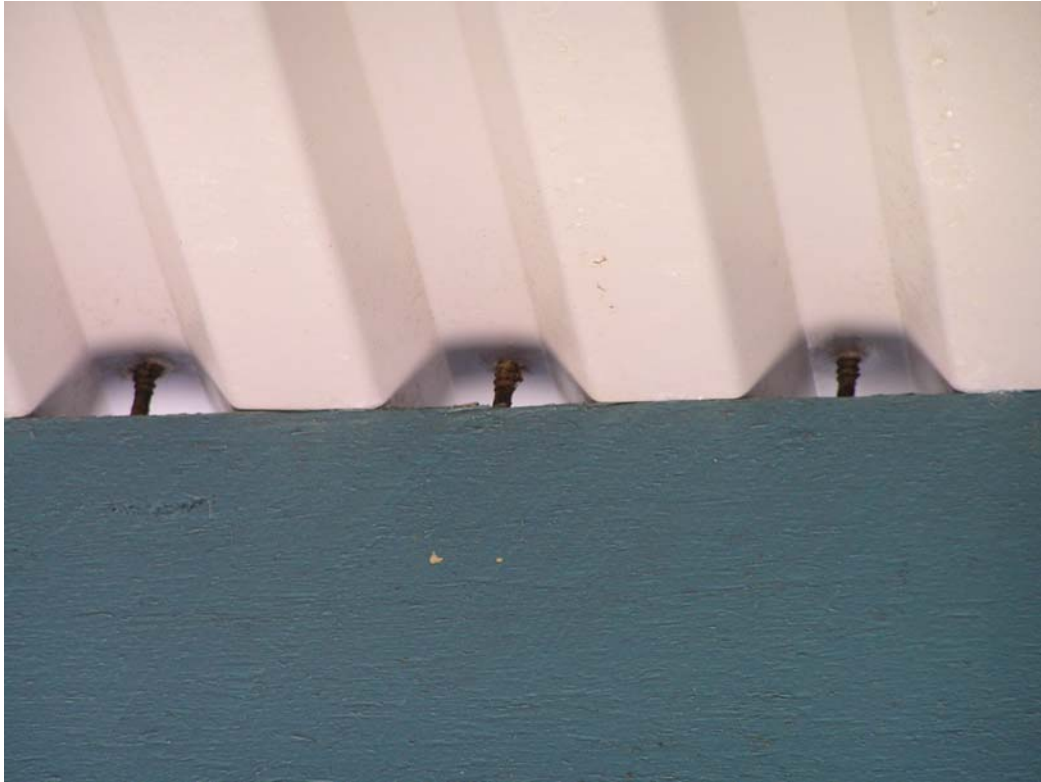
Figure 26 Covered walkway, fastener shanks are red rust and undercutting seen on Colorbond sheeting.

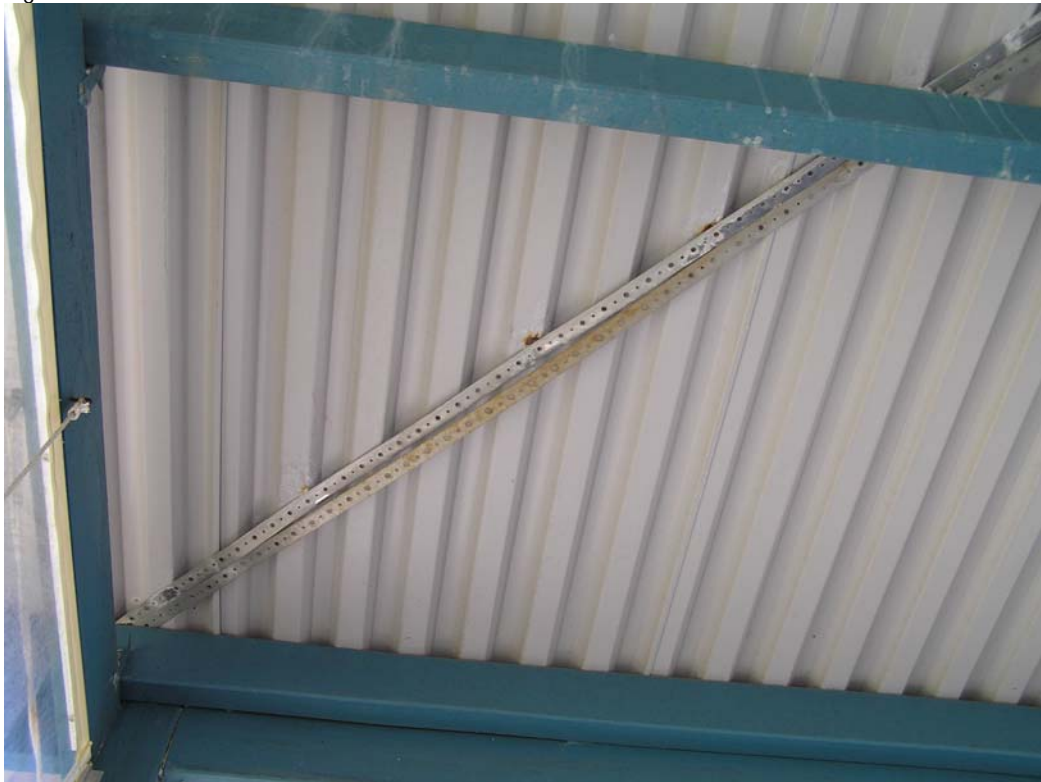
The following figures show an attempt at building with more corrosion resistant components but actually causing additional problems. Stainless steel strapping was used in the construction of the Covered set down but it is in contact with the Colorbond roof sheeting. The strap that is not in contact is corroding and the strap in contact with the Colorbond is causing the Colorbond to corrode. The Colorbond is showing significant red rust and will in the near future if it hasn't already, corrode through. This could have been avoided by making sure the strapping did not touch the Colorbond sheeting.

Figure 29 Covered set down showing red rust of stainless steel strapping not in contact with roof sheeting and red rust on roof sheeting where stainless steel strapping is in contact.

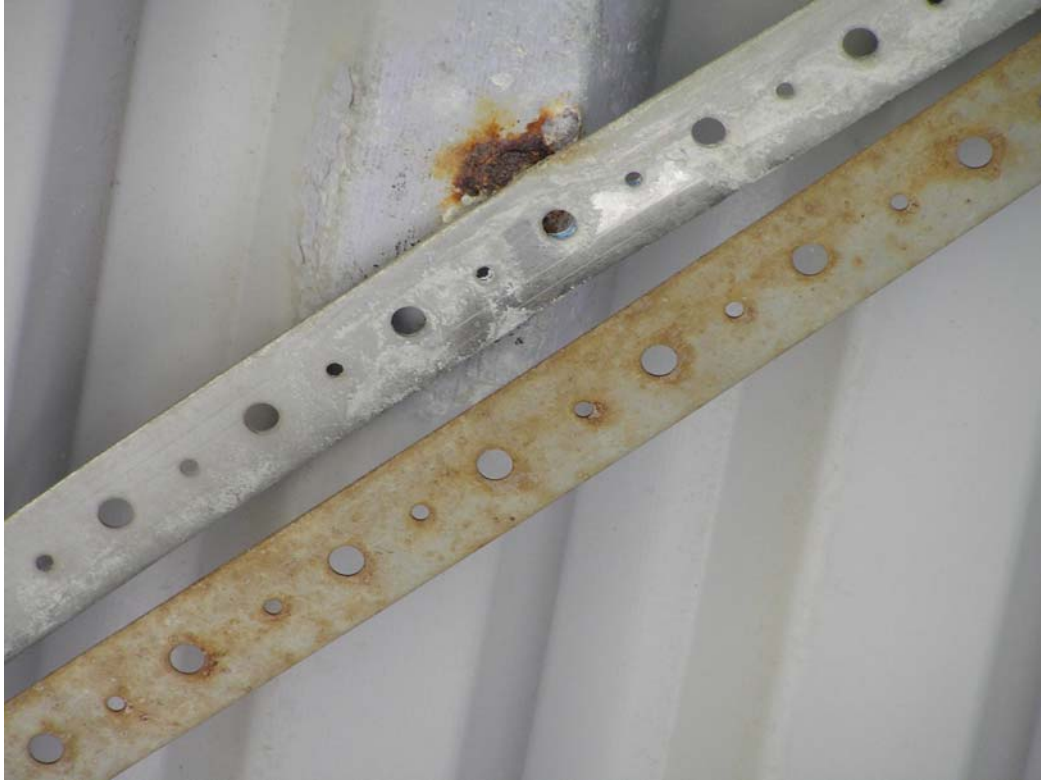
Figure 30 Close up showing red rust of stainless steel strapping not in contact with roof sheeting and red rust on roof sheeting where stainless steel strapping is in contact.

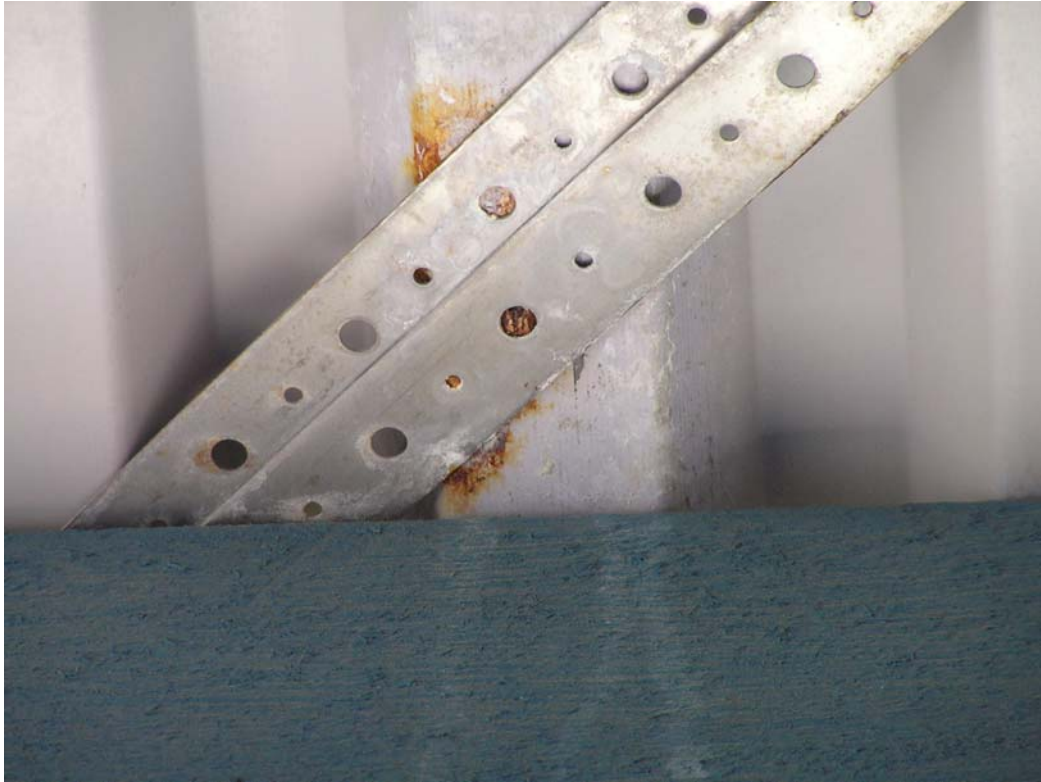
Figure 32 Close up showing red rust on roof sheeting where stainless steel strapping is in contact.

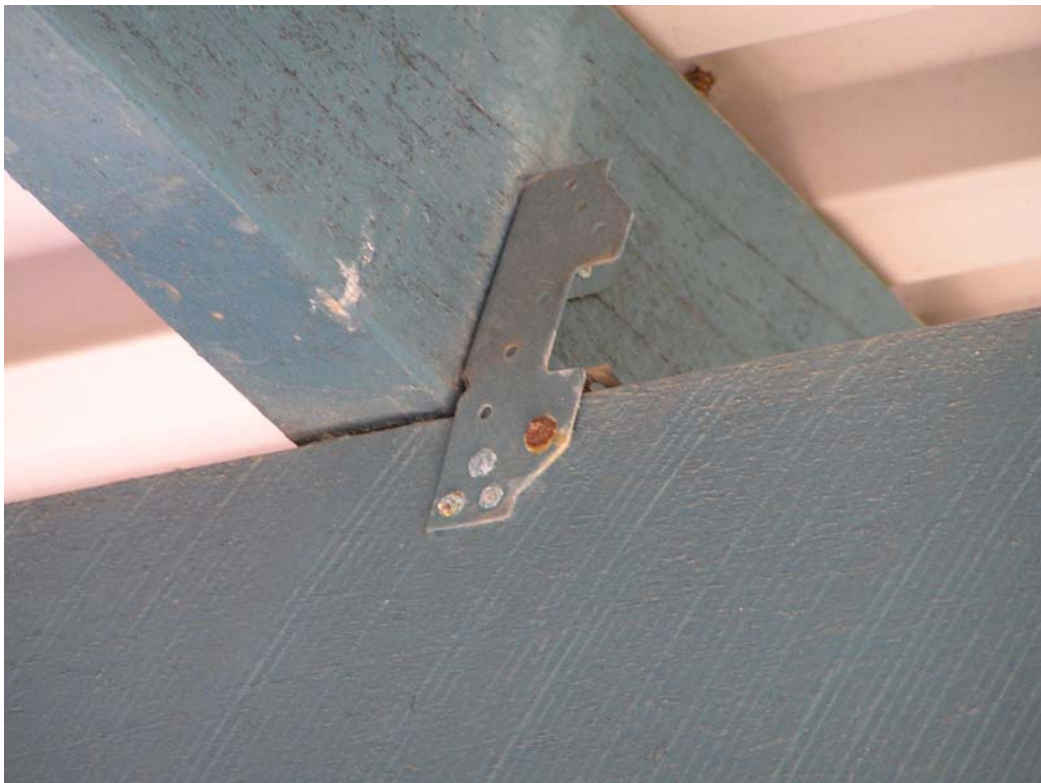
Figure 33 Triple grips on structure of covered set down showing signs of deterioration and roof fastener shank to red rust.

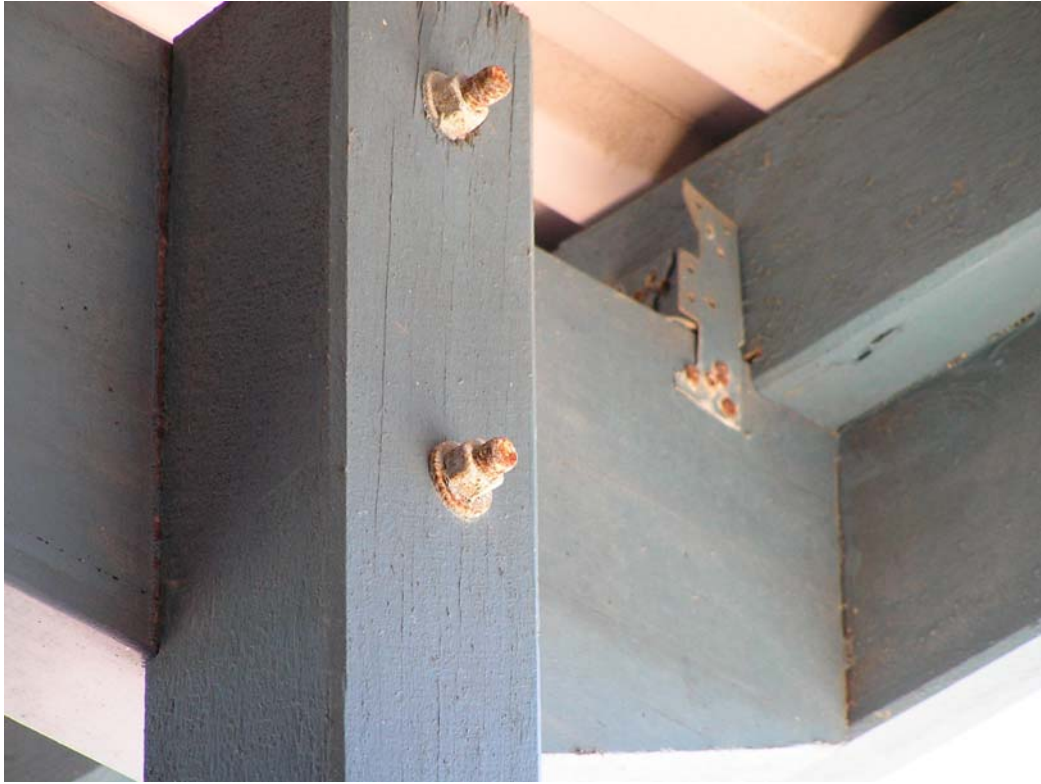
Figure 34 Triple grips and bolts on structure of covered set down showing signs of deterioration.

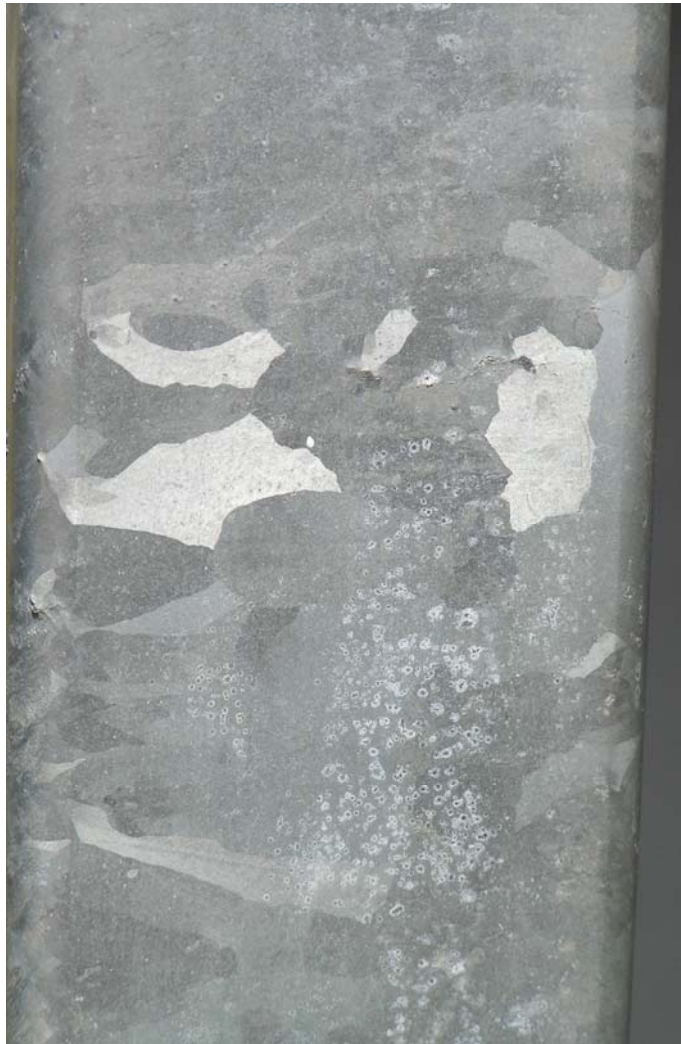
Figure 39 Galvanised post on Administration Block and close up showing signs of white corrosion product.

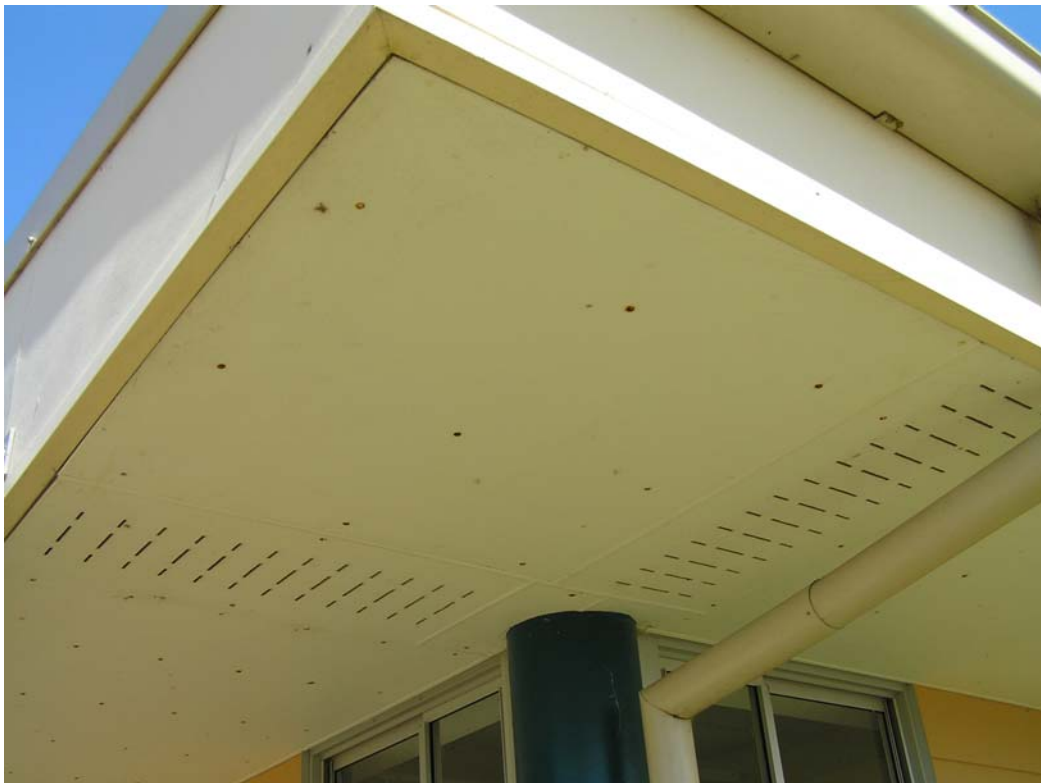
Figure 41 Rust on fasteners on Block N.

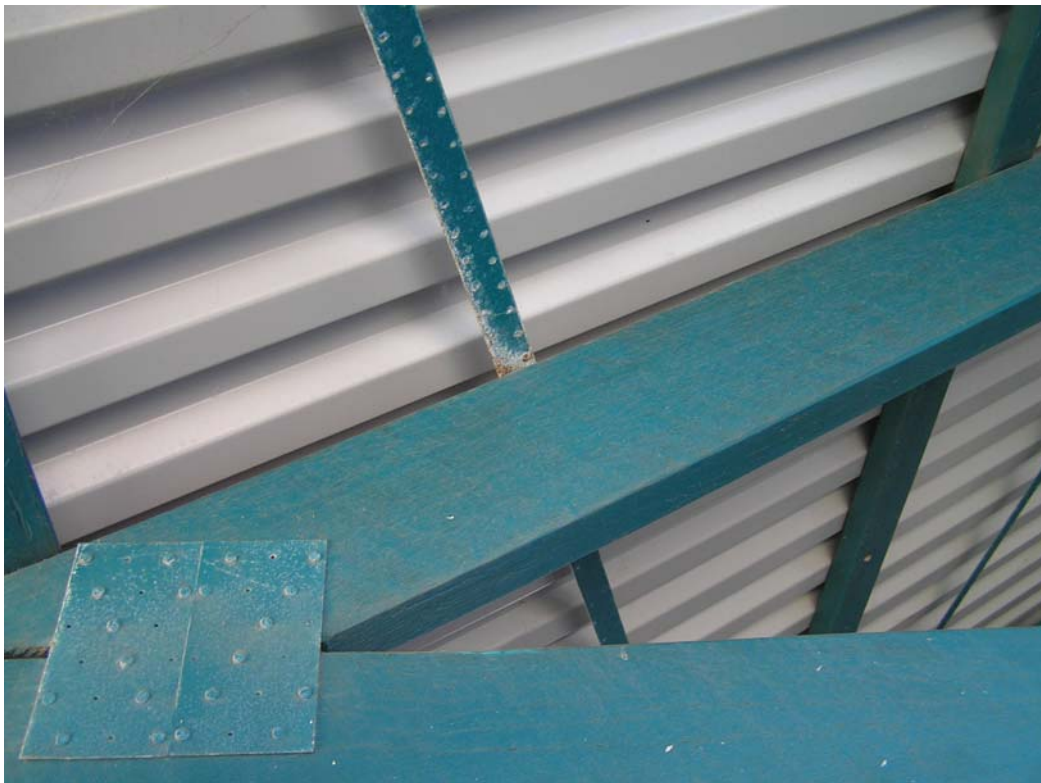
Figure 43 Corroded strapping on covered court.

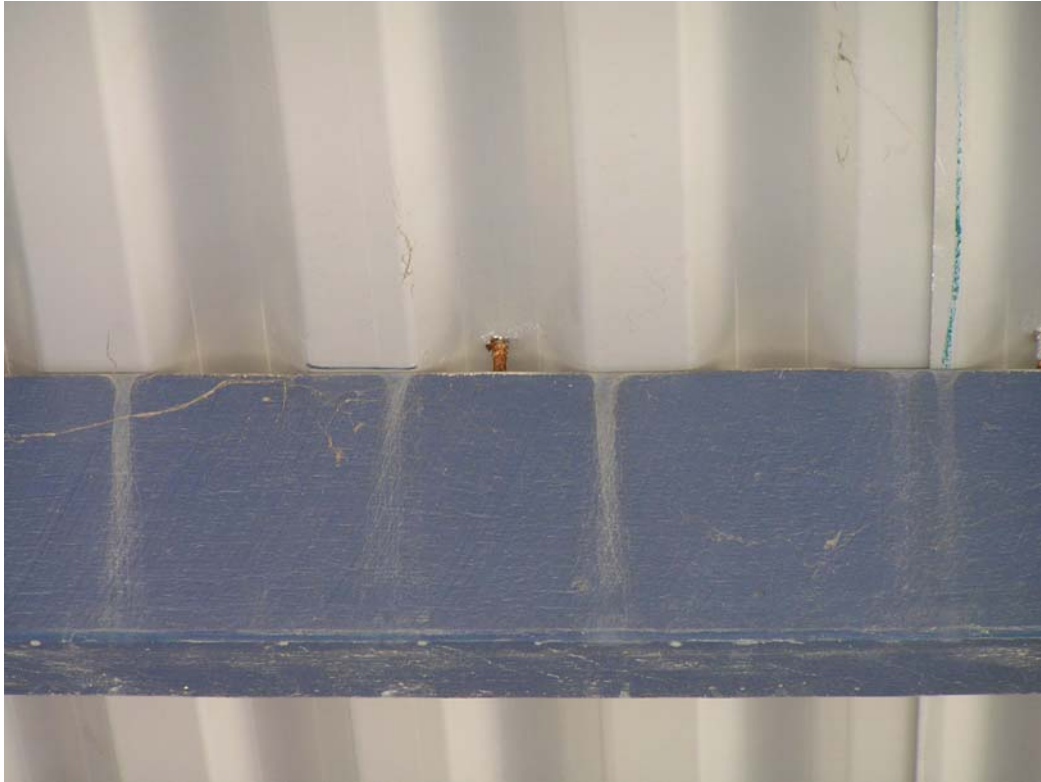
Figure 44 Corroded fasteners in covered walkway.

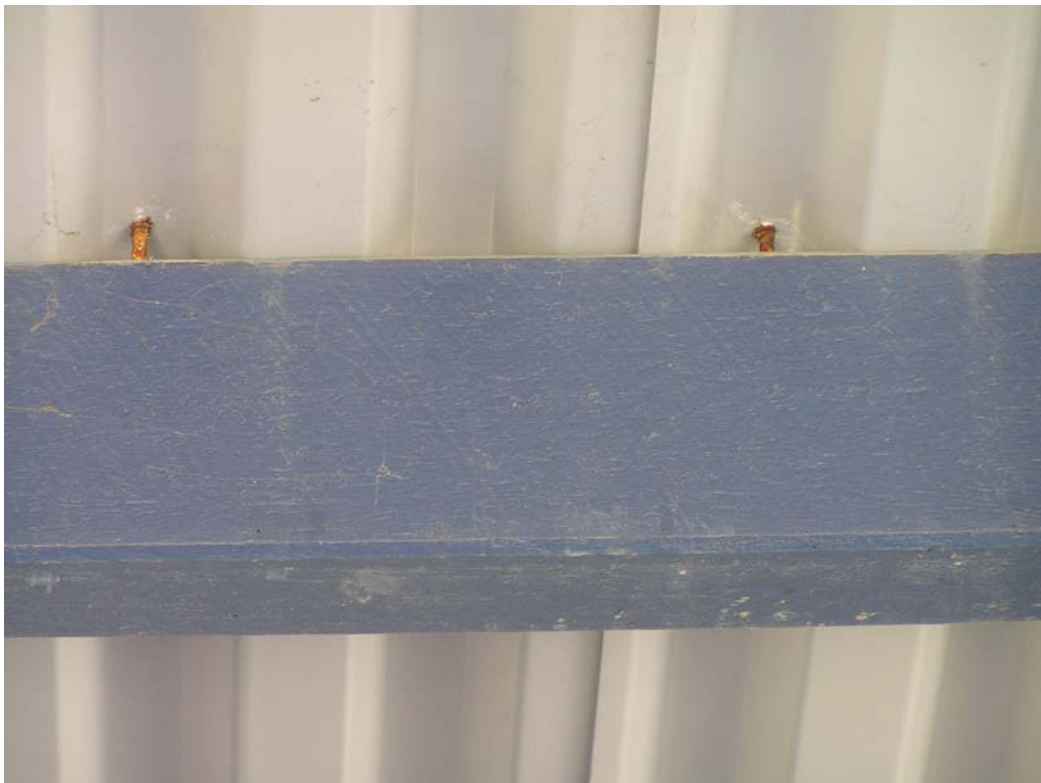
Figure 45 Corroded fasteners in covered walkway.

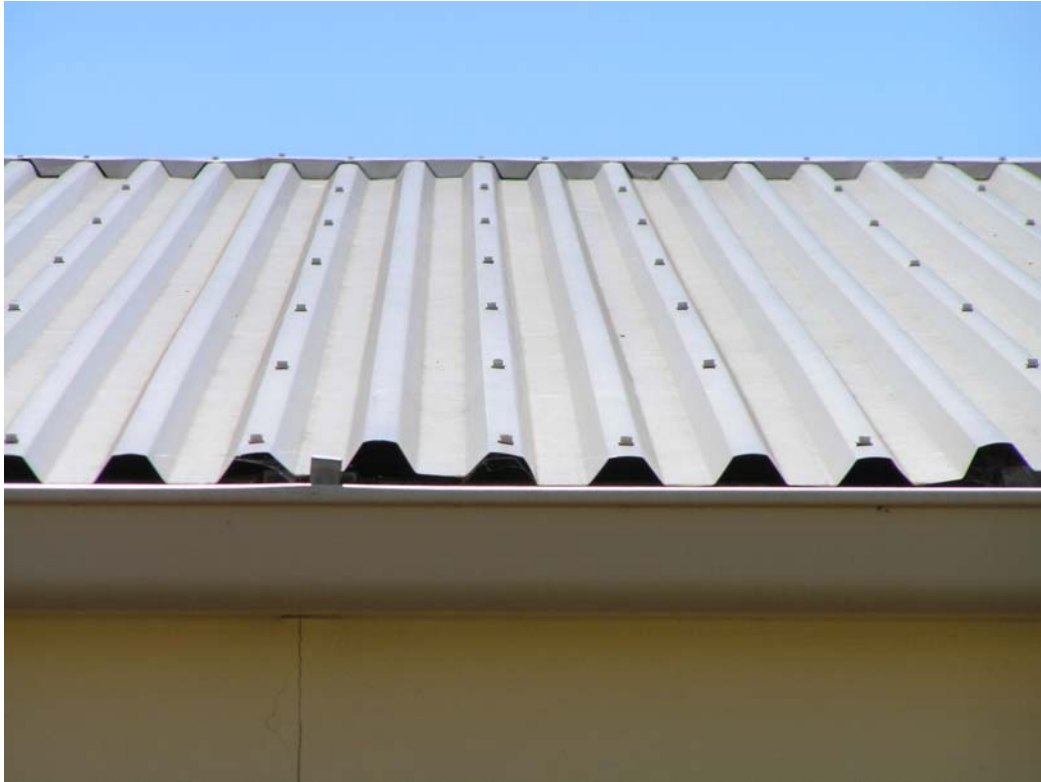
Figure 46 Roof of building, heads of fasteners and roof in good condition.

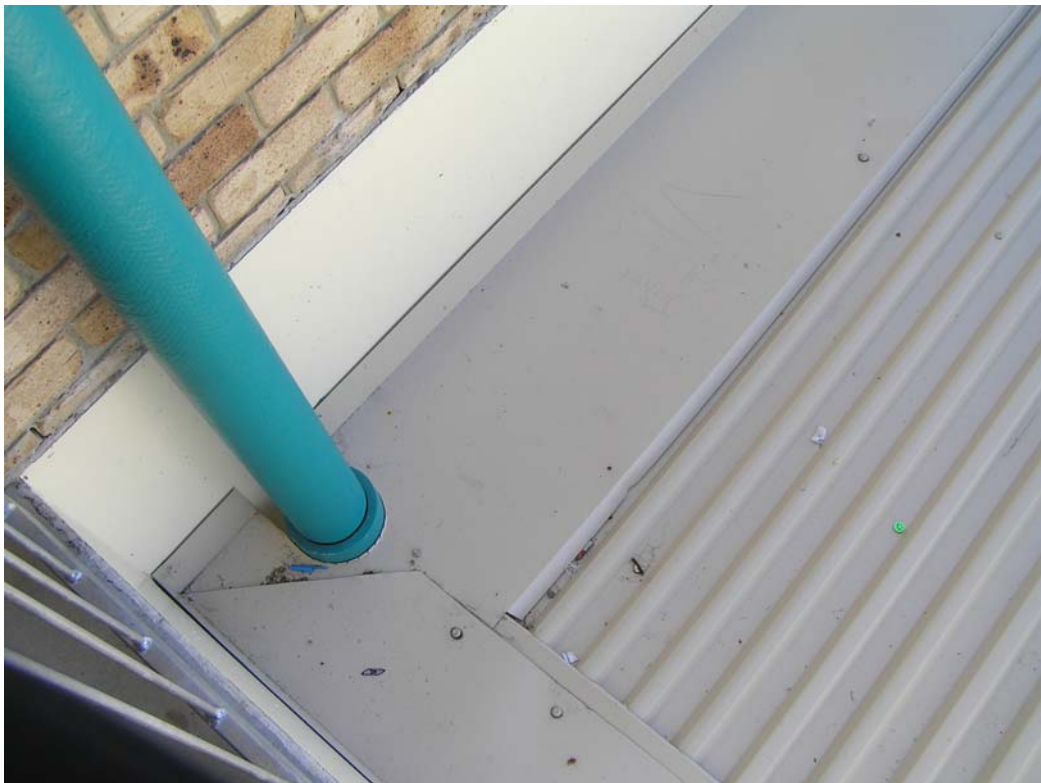
Figure 50 Roof of covered walkway from block G showing rust stains from discarded swarf.

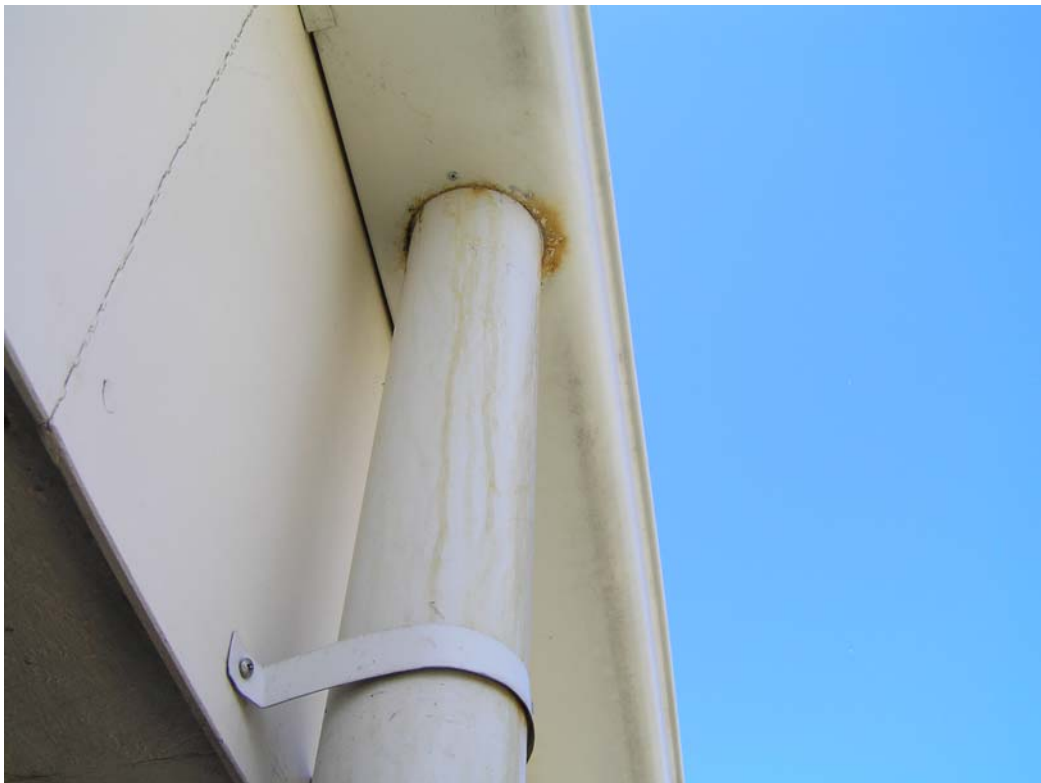
Figure 52 Degradation of gutter at join.
